Storage Tank RBI web application

Inventure Activities

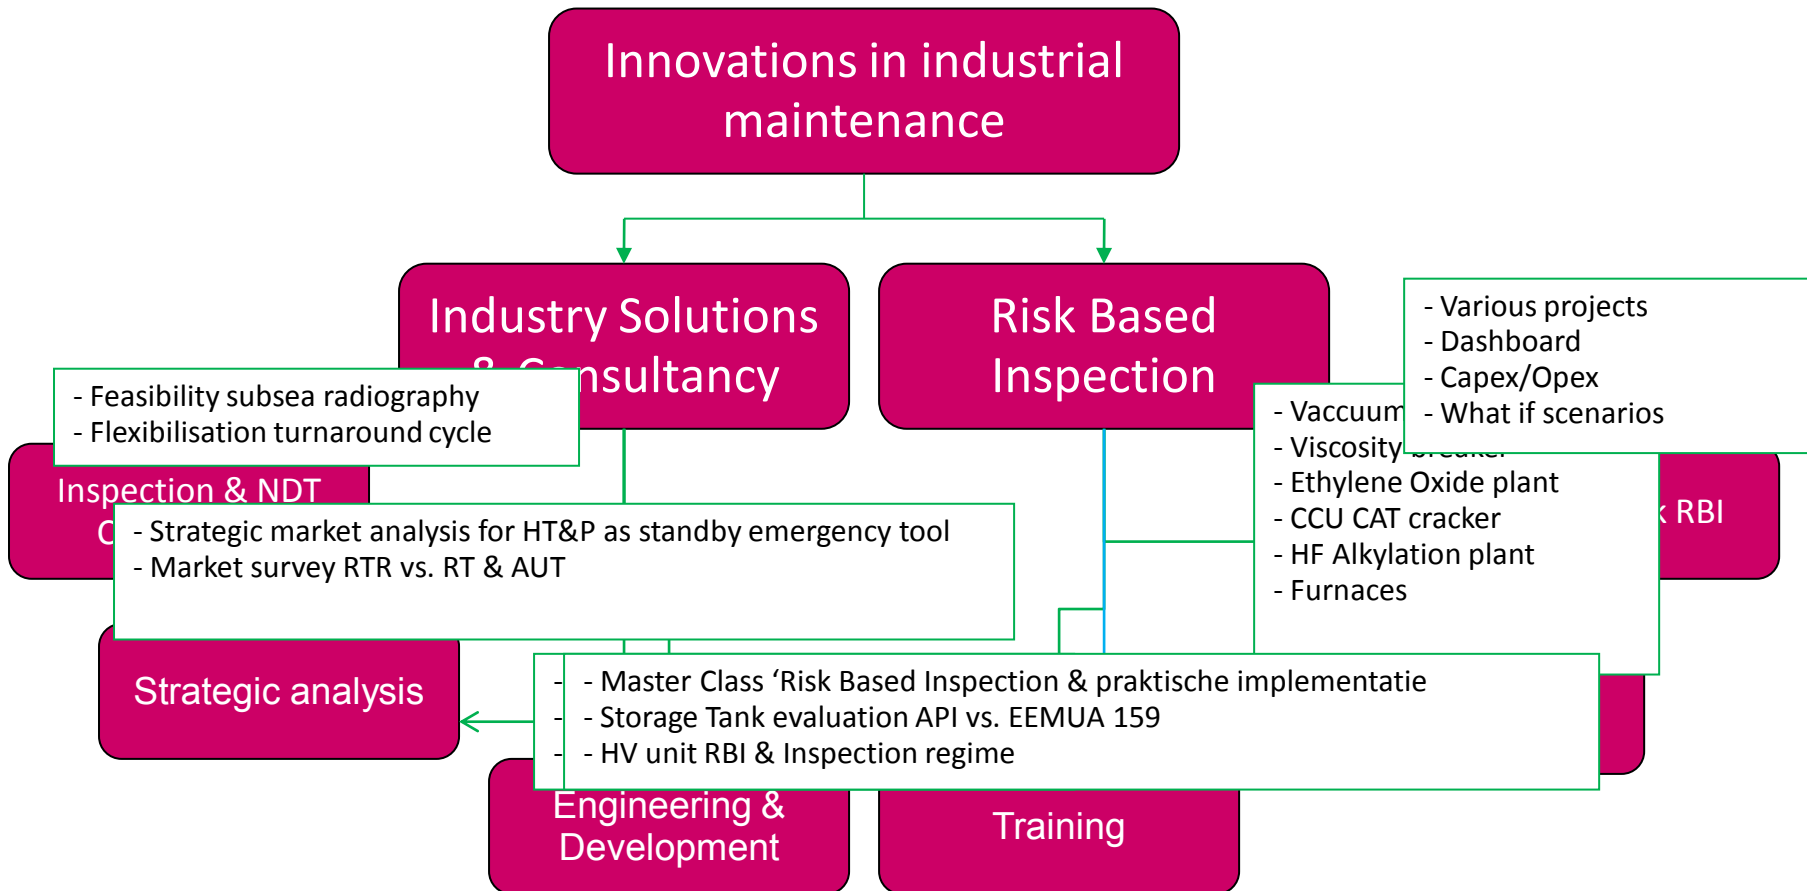
Application schematic

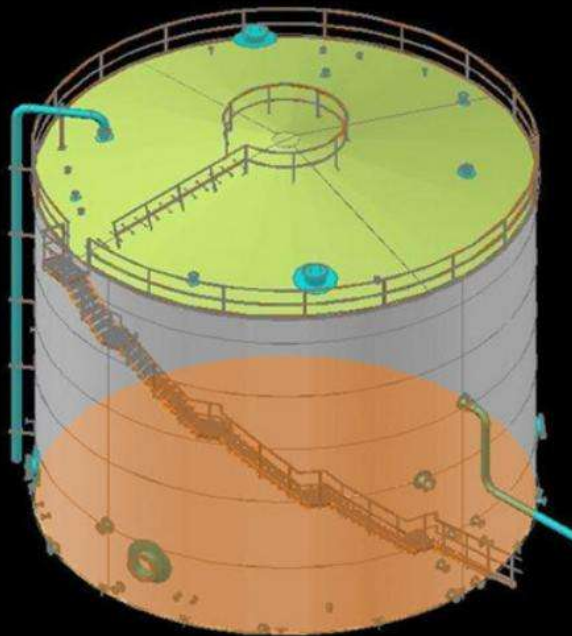
TANK DETAILS:

Tank name:	TESTTANK
Type:	Low pressure tank
Capacity:	31252 m3
Roof type:	Fixed roof
Diameter:	48 m
Height:	19.2 m
Rings:	8
Date of constr.:	1976-05-04
Design code:	BS2654
Product:	Nafta
Joint efficiency factor:	1
Design pressure:	20
Design vacuum pressure:	7.5
Max filling height :	17.28
